Manhole Inspection Summary

Manhole # S49A2_006MH

Location Address: **1530 E. Patapsco Ave.**

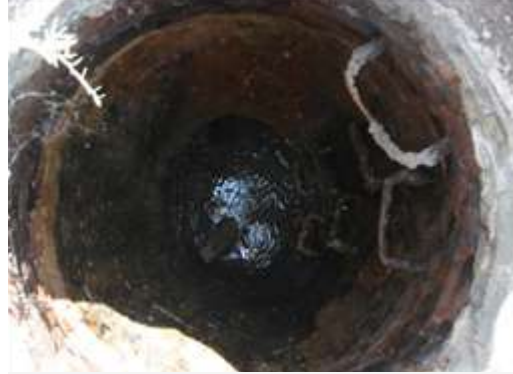
Top View and Steps

Steps Count: **8** Missing: **0** ☒ **Corroded**

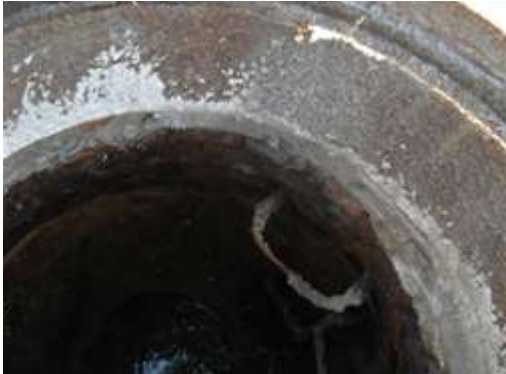
Defect 2

Corroded steps

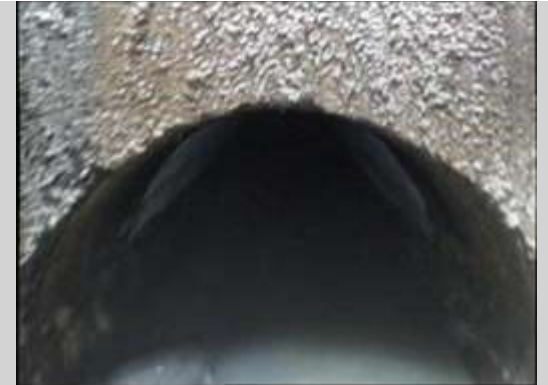
12 O'Clock Outflow

42 in. Circular Gravity Sewer
Pipe Out @ 12 O'Clock

Pipe Height: **34.8** (in.) Rod and Bar (Angled)
Pipe Material: **Concrete** ☐ Pipe Lined
Invert Depth: **14.90** (ft.) Flow Characteristics: **Fast**
Deposits: ☐ None ☐ Mud ☐ Gravel ☒ **Debris** ☐ Grease
Silt Depth: **2** (in.) Deposits Extent: **Medium**
Infiltration: **None** Pipe Seal Cond: **Sound**

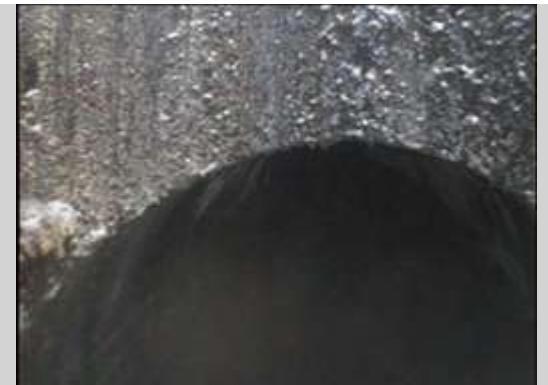
6 O'Clock Inflow

42 in. Circular Gravity Sewer
Pipe In @ 6 O'Clock

Pipe Height: **37.2** (in.) Rod and Bar (Angled)
Pipe Material: **Concrete** ☐ Pipe Lined
Invert Depth: **15.00** (ft.) Flow Characteristics: **Fast**
Deposits: ☐ None ☐ Mud ☒ Gravel ☒ **Debris** ☐ Grease
Silt Depth: **2** (in.) Deposits Extent: **Medium**
Infiltration: **None** Pipe Seal Cond: **Sound**
